# Manhole Inspection Summary

Manhole # S15II1018MH

Insp Date: **3/1/07 12:55 PM**

**Location** Address: **2418 LOYOLA NORTHWAY**

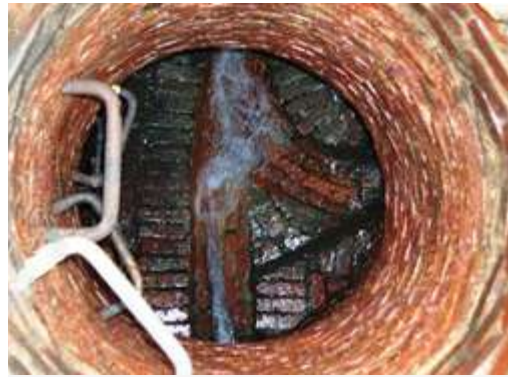
Top View

Corroded steps. Evidence of surcharge - Bench debris. Bench deterioration.

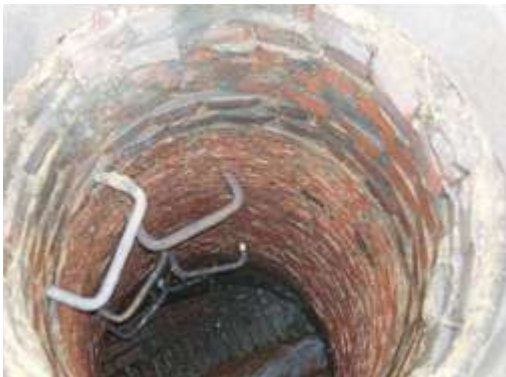
Defect

Frame leaks. Frame offset. Adjustment deterioration and infiltration. Evidence of surcharge.

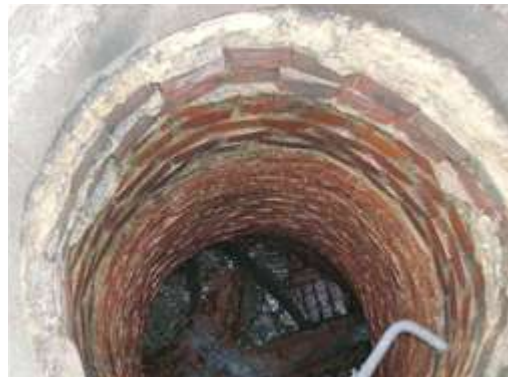
Defect

Frame leaks. Frame offset. Adjustment deterioration and infiltration - other side.

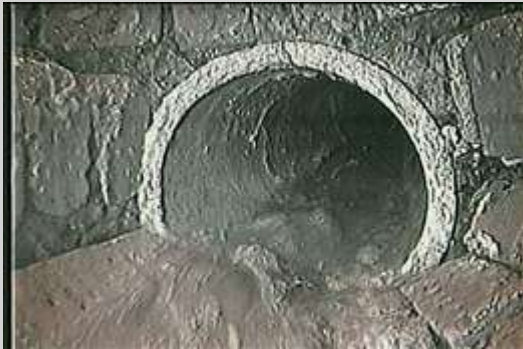
### 8 in. Circular Gravity Sewer Pipe Out @ 12 O'Clock

Infiltration: **Evidence** Pipe Seal Cond: **Cracked**

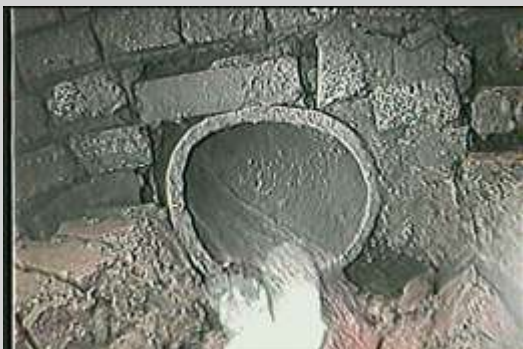
### 8 in. Circular Gravity Sewer Pipe In @ 3 O'Clock

Barrel deterioration and infiltration. Bench and Channel deterioration.

Infiltration: **Evidence** Pipe Seal Cond: **Broken**

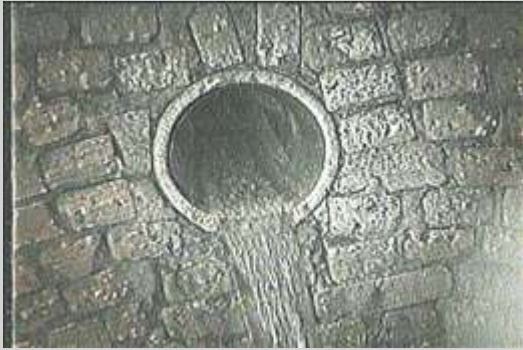
Pipe In @ 6 O'Clock

Infiltration: **Evidence**
